SAMPLE GLAZE-IN ELEVATION
APPLIED TO CURTAINWALL

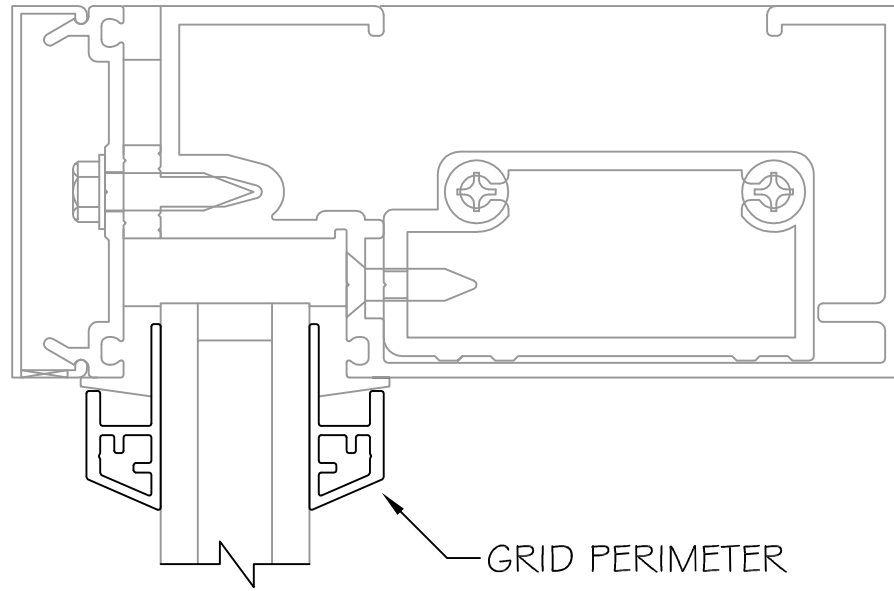
BVB-5 AT CURTAIN WALL HEAD

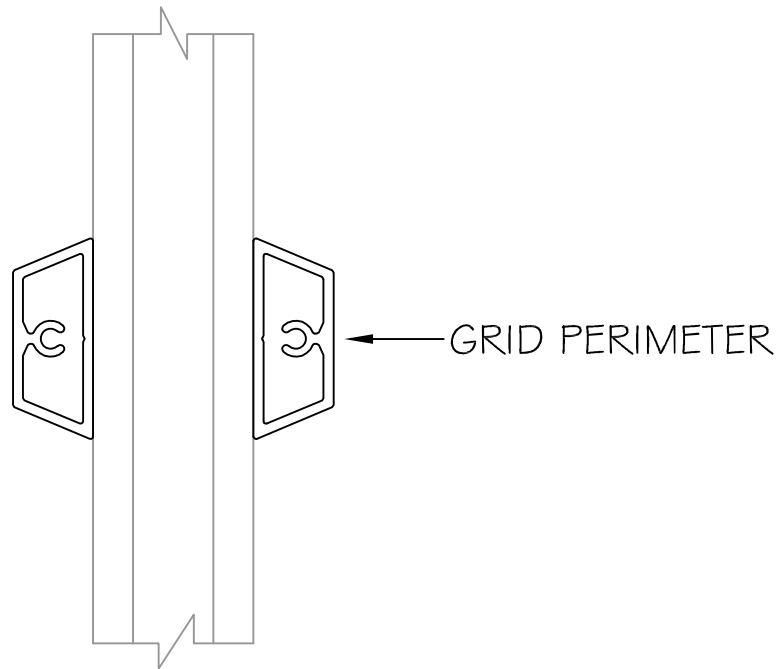
BVB-4 AT HORIZONTAL INTERSECTION
